## **SR 3 MP 49.48 Big Scandia Creek (996804): Preliminary Hydraulic Design Report**

**JULIE HEILMAN, PE (FPT20-03166)  
STATE HYDRAULIC ENGINEER  
Y-12554 Olympic Region GEC**

**Sulochan Dhungel, P.E., Lead Design Engineer,  
David Evans and Associates, Inc. (FPT20-37787)**

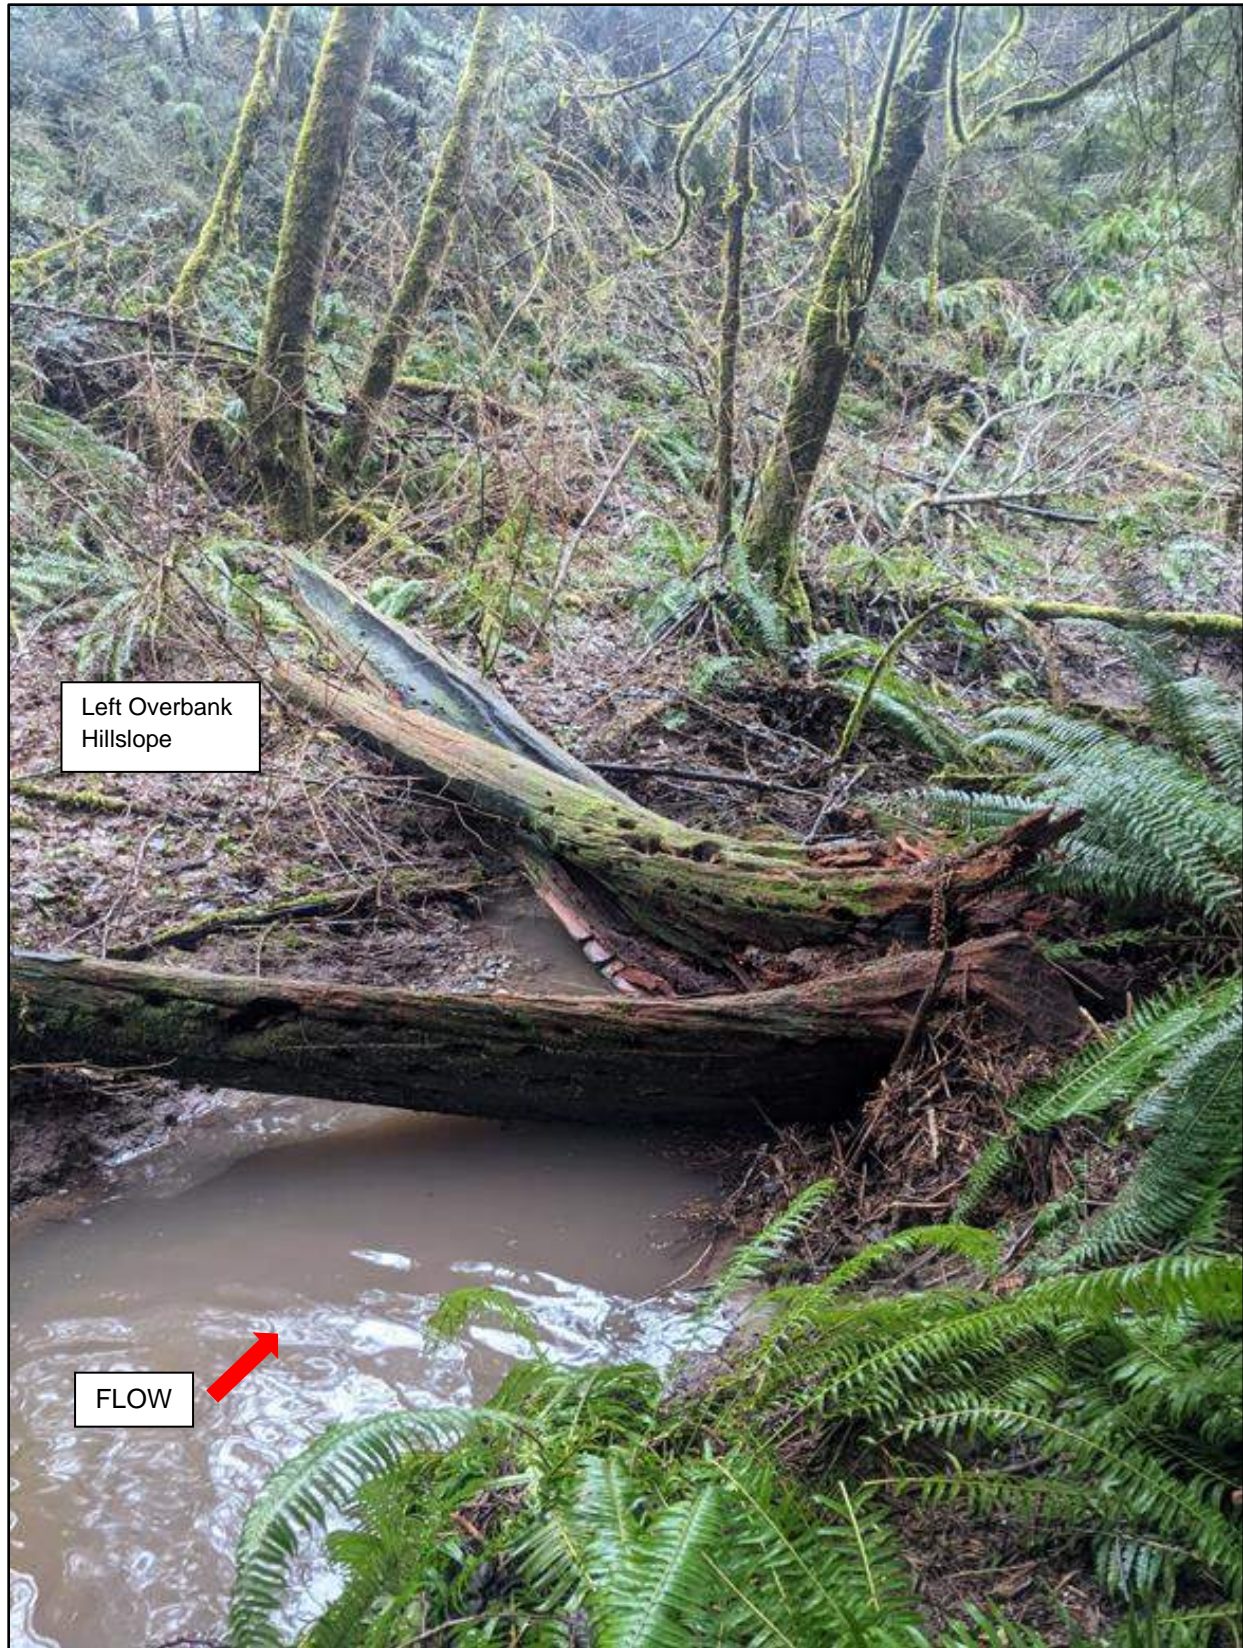
Figure 11: Reference reach upstream of SR 3 (some LWM present on the stream) (approx. STA 5+75)

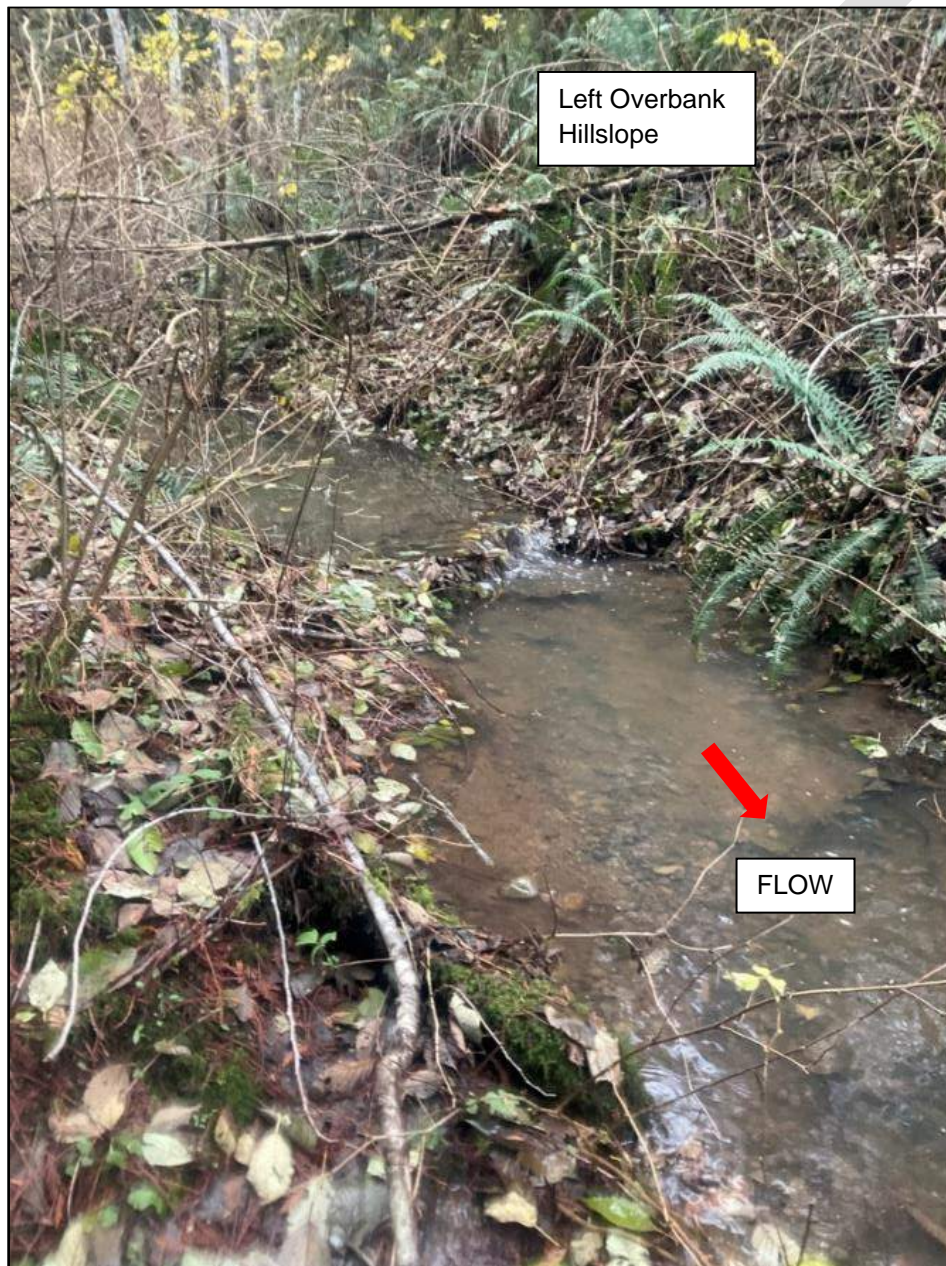
The channel downstream of the reference reach, between approximately Station 5+60 to Station 4+90, was shallow, and the channel slopes were approximately 1.3 percent. The left overbank is a relatively steep hillslope, which could be a result from the fill of road embankment and this section is where the stream bends to the south-west (see Figure 12). The bend causes the channel to lose some energy and with reduced velocities, aggradation of fine materials and organic matter in the streambed can be observed (see Figure 13). These low energy flows could be attributed to the presence of the culvert, which is preventing the channel from attaining a natural flow regime. In this section, a few tree logs were present that were less than 12 inches in diameter (see Figure 14). The vegetation along this section is cedar, red alder, salmonberry, and swordfern. This vegetation provides some shade, but tree canopy cover is limited in this section.

**Figure 12: View of channel near STA 5+00**

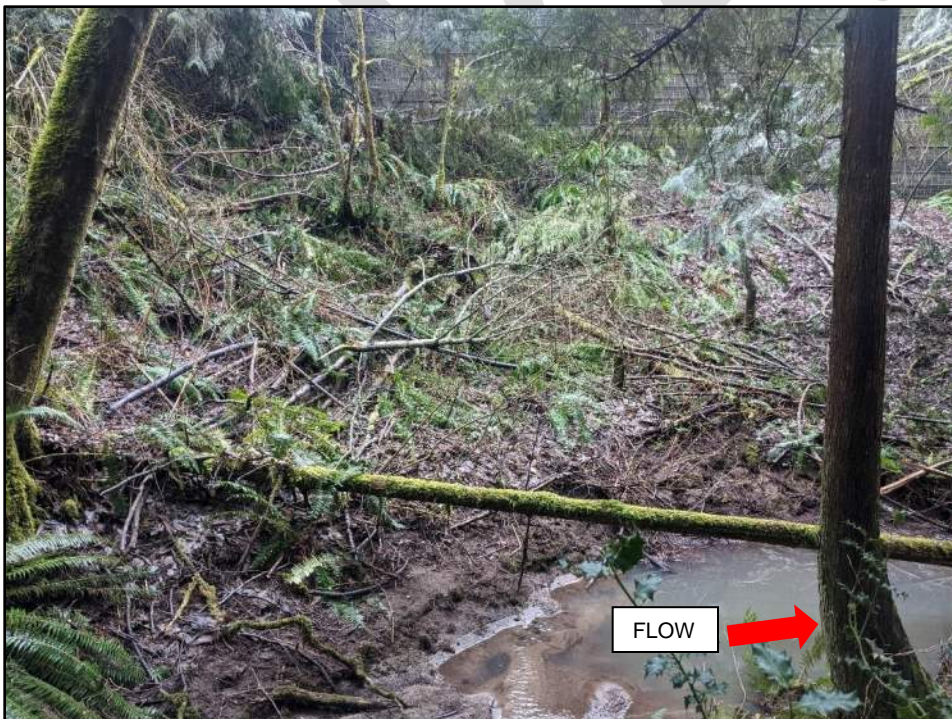
**Figure 14: Woody material at the left overbank and tree logs near STA 5+30**

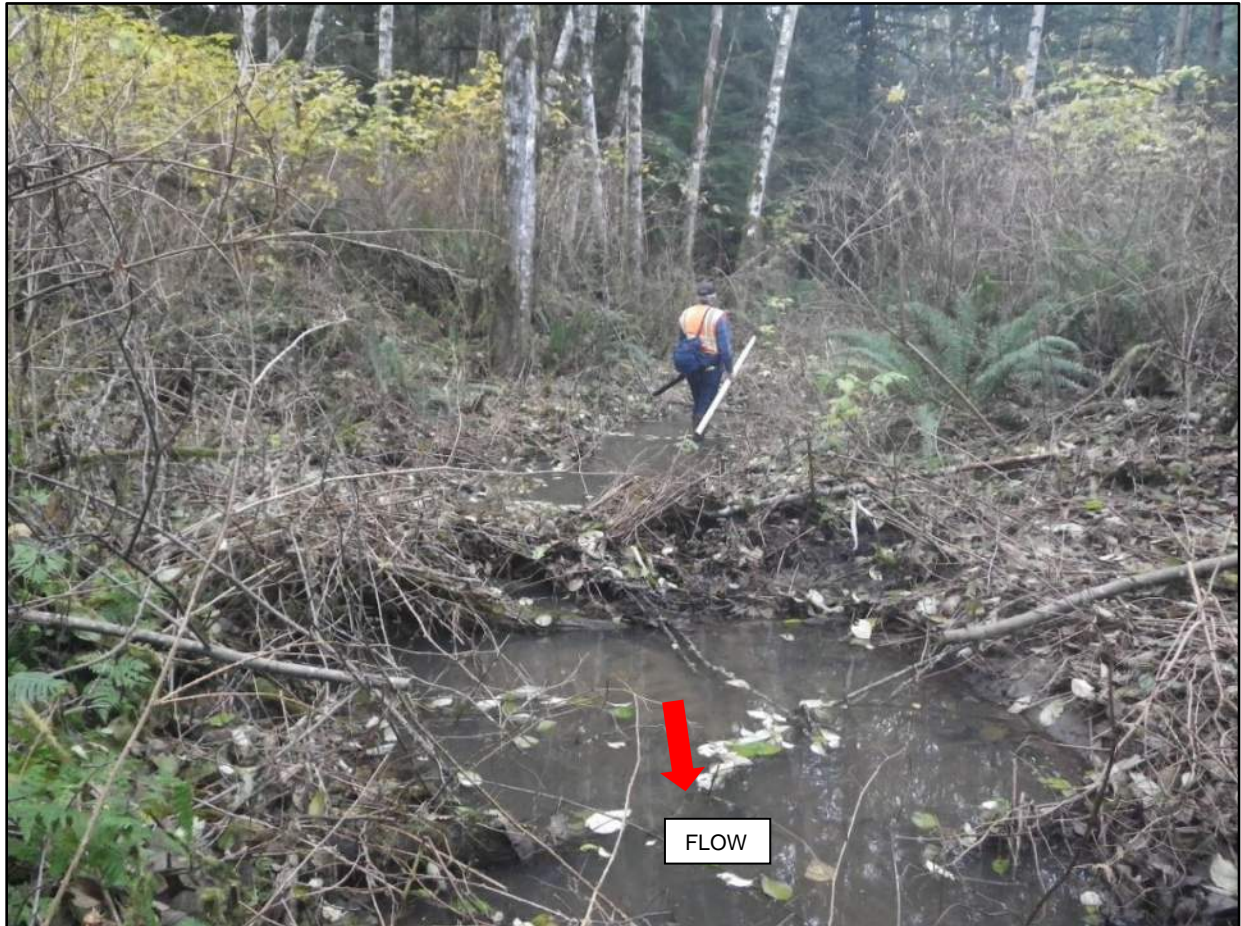
**Figure 15: Woody material near STA 4+50**

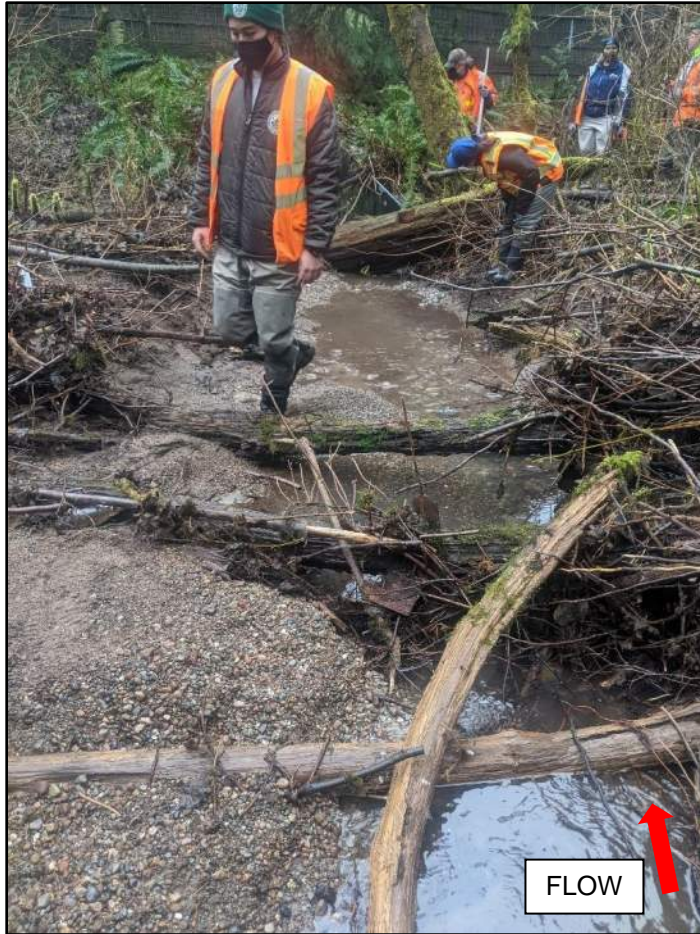
**Figure 20: Woody material and bed material near STA 4+20**

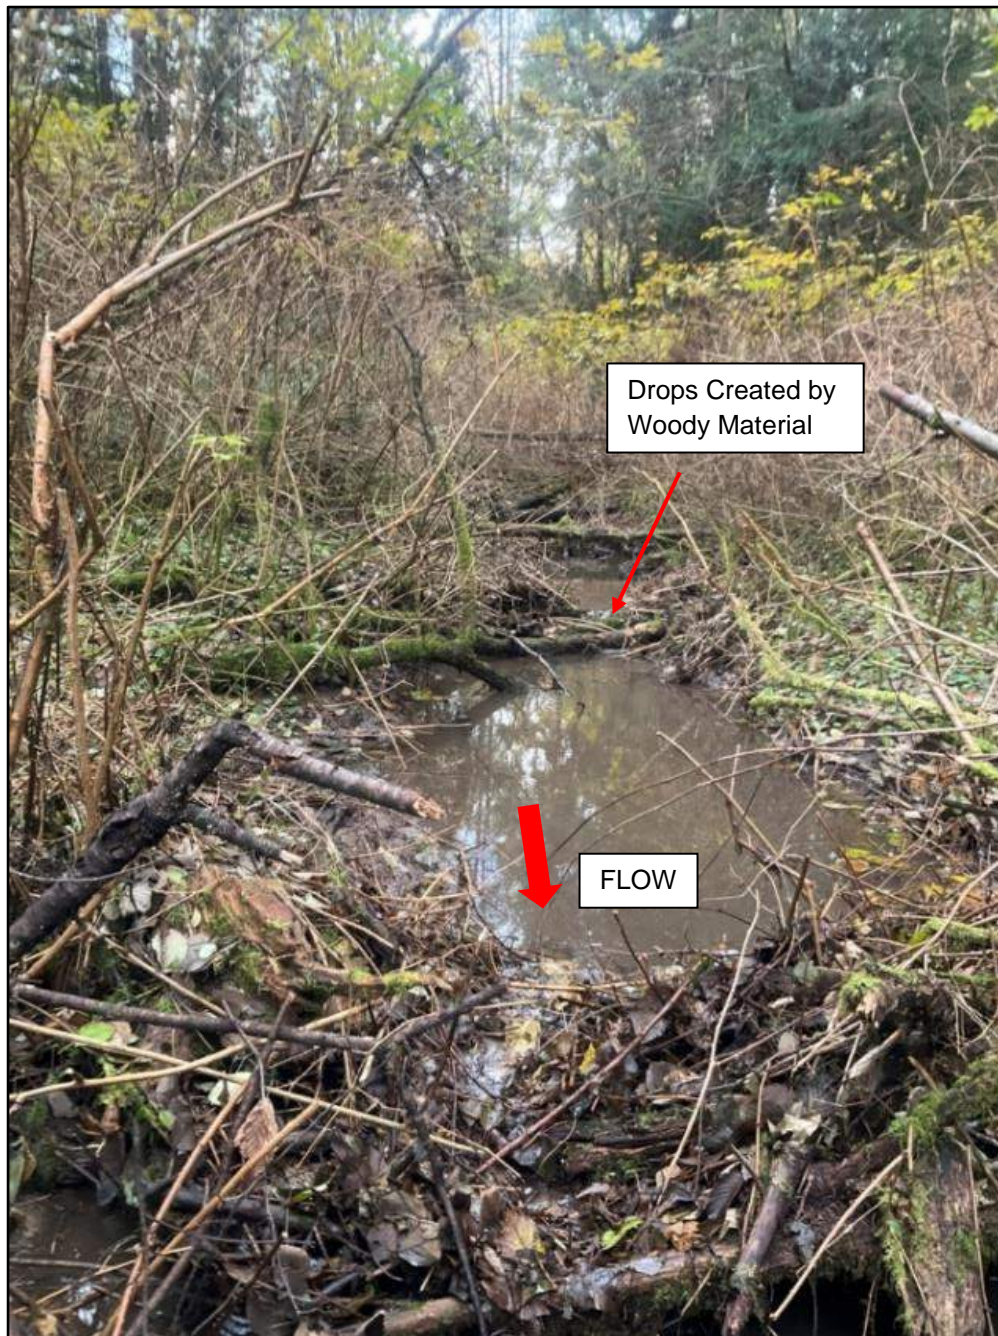
**Figure 21: Drops created by small woody material near STA 1+40**

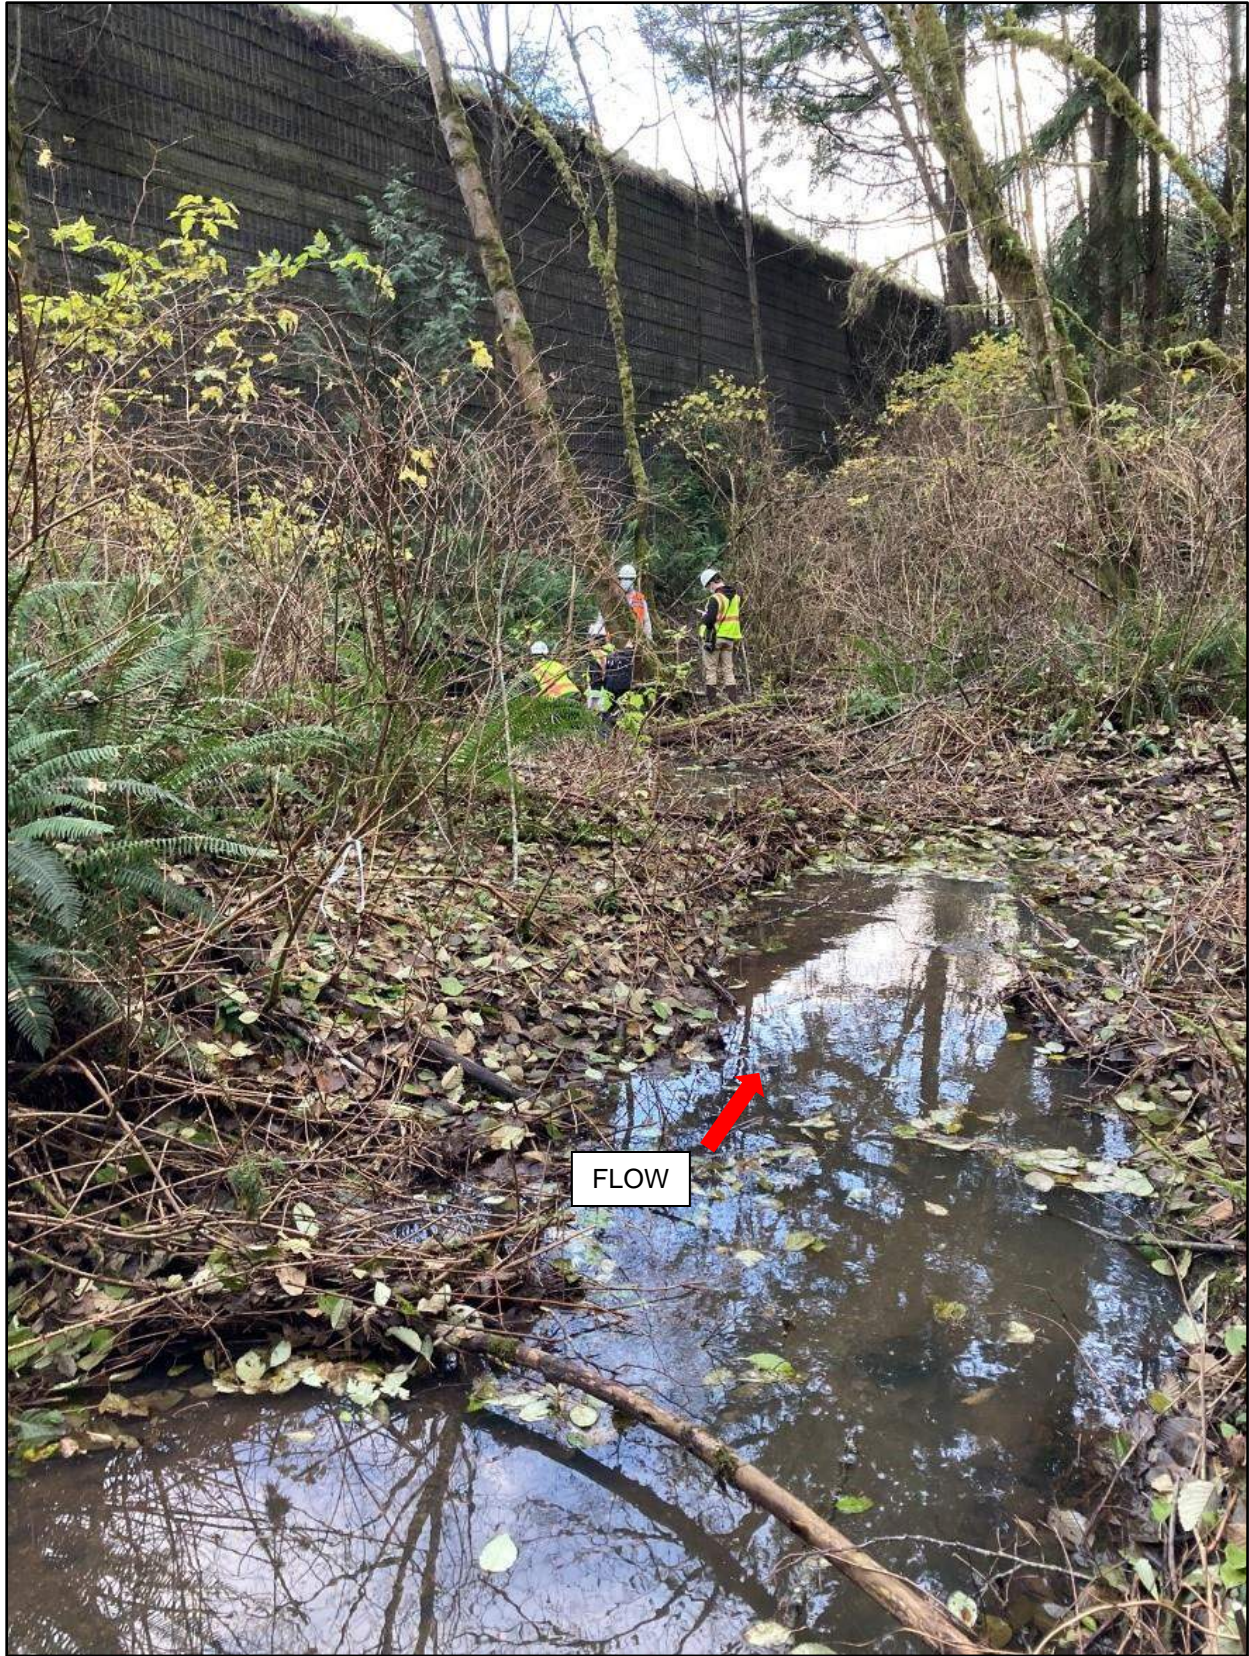
**Figure 27: Upstream of culvert looking towards culvert inlet and highway**

In the existing conditions, the culvert restricts free flow, as evidenced by the pooling upstream of the culvert. This restriction of free flow might have reduced energy in the flow within the channel upstream of the culvert, which also reduces incision. This reduction of energy causes some lateral movement of the channel but the hillslope on both sides restricts large significant lateral movements. However, when a new structure that allows free flow is installed, this limited lateral movement would also be reduced.

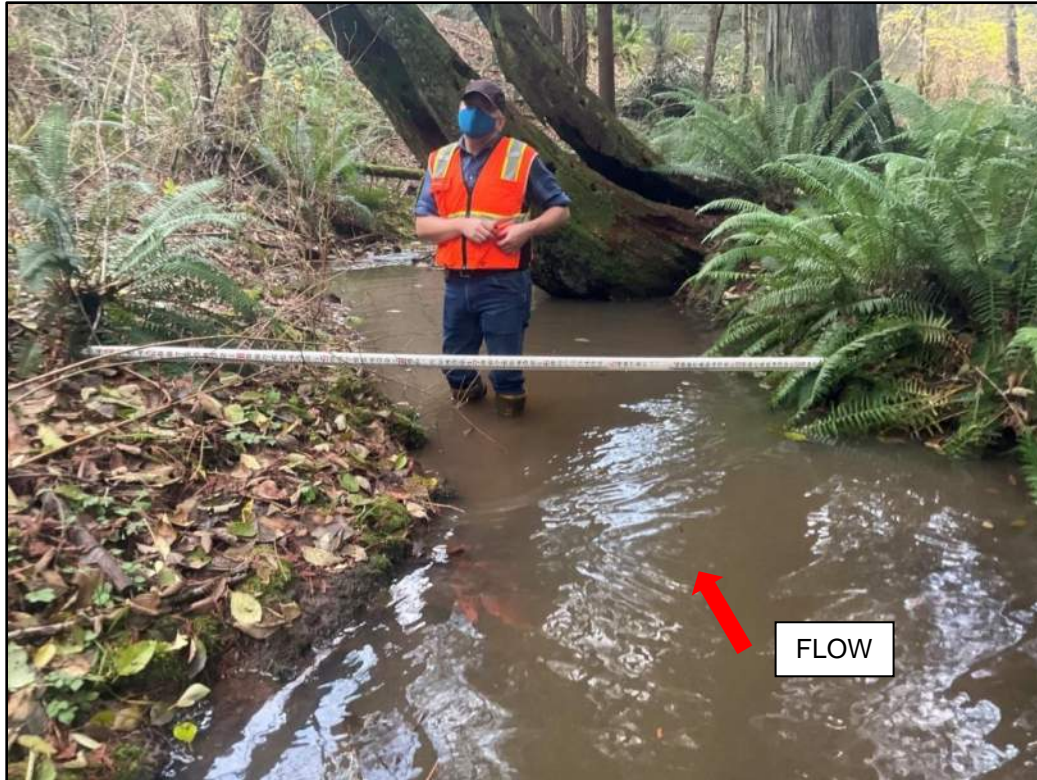
**Figure 28: BFW-5 measurement of 8 feet, measured within the reference reach approximately 180 feet upstream of the culvert**

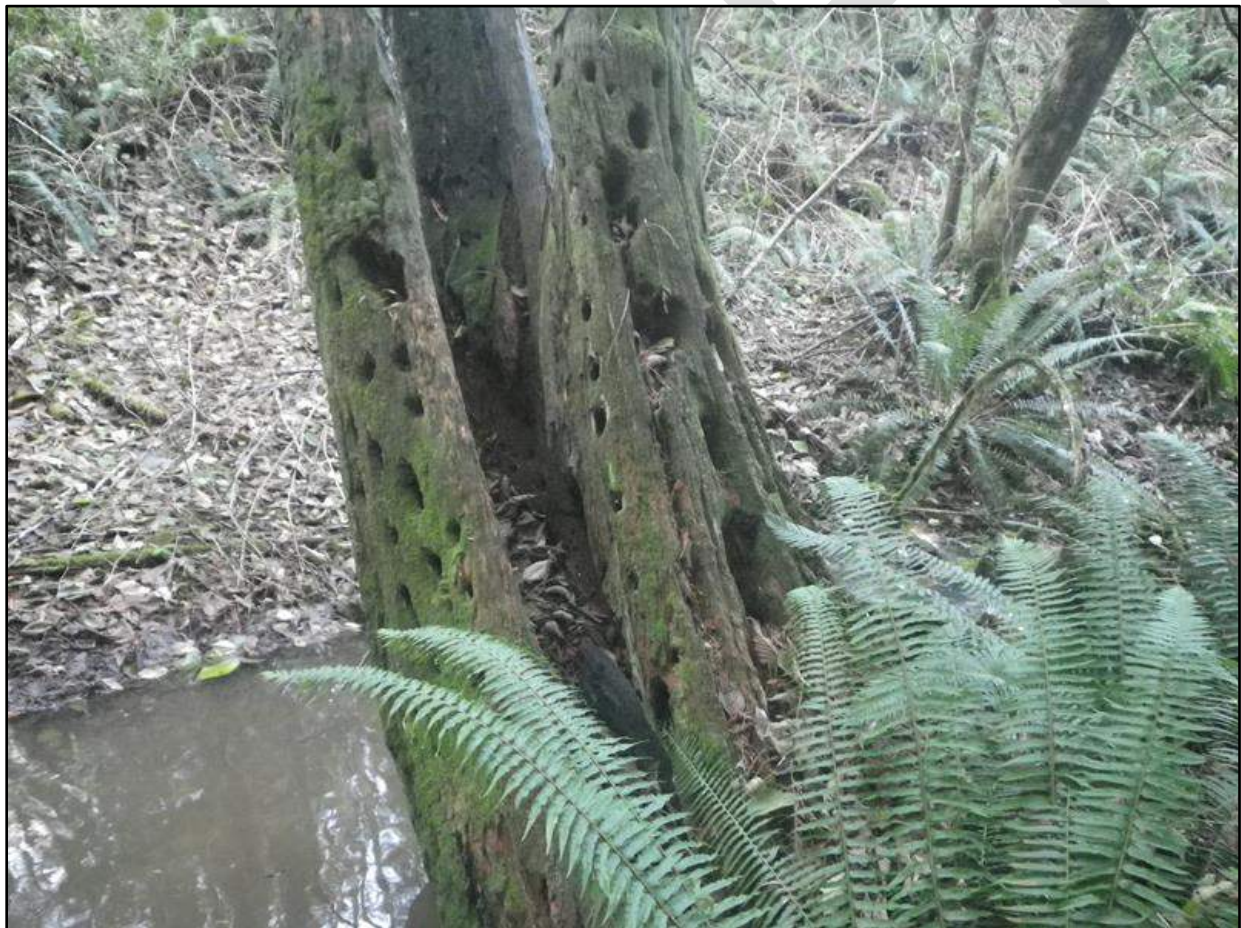
No evidence of recent lateral erosion was observed in the field nor was longer-term channel migration observed in the field or from review of the LiDAR topography. The likeliest mechanism for a change in the channel form would be tree falls obstructing the channel and creating local adjustments; however, no LWM was observed in the channel during the December 2, 2021, site visit. However, some stream-adjacent trees had fallen during a storm event before the February 5, 2022, site visit. There was a large butt log, approximately 10 feet tall, that was leaning towards the channel at the downstream end of the reference reach (visible in Figure 30) that

was in an advanced state of decay (see Figure 42) and has likely been in that position for many years. This condition of this log indicates long-term stability at the downstream section of the reference reach.

**Figure 42: Decay of butt log, approximately 10 feet long, leaning into channel at downstream end of reference reach**

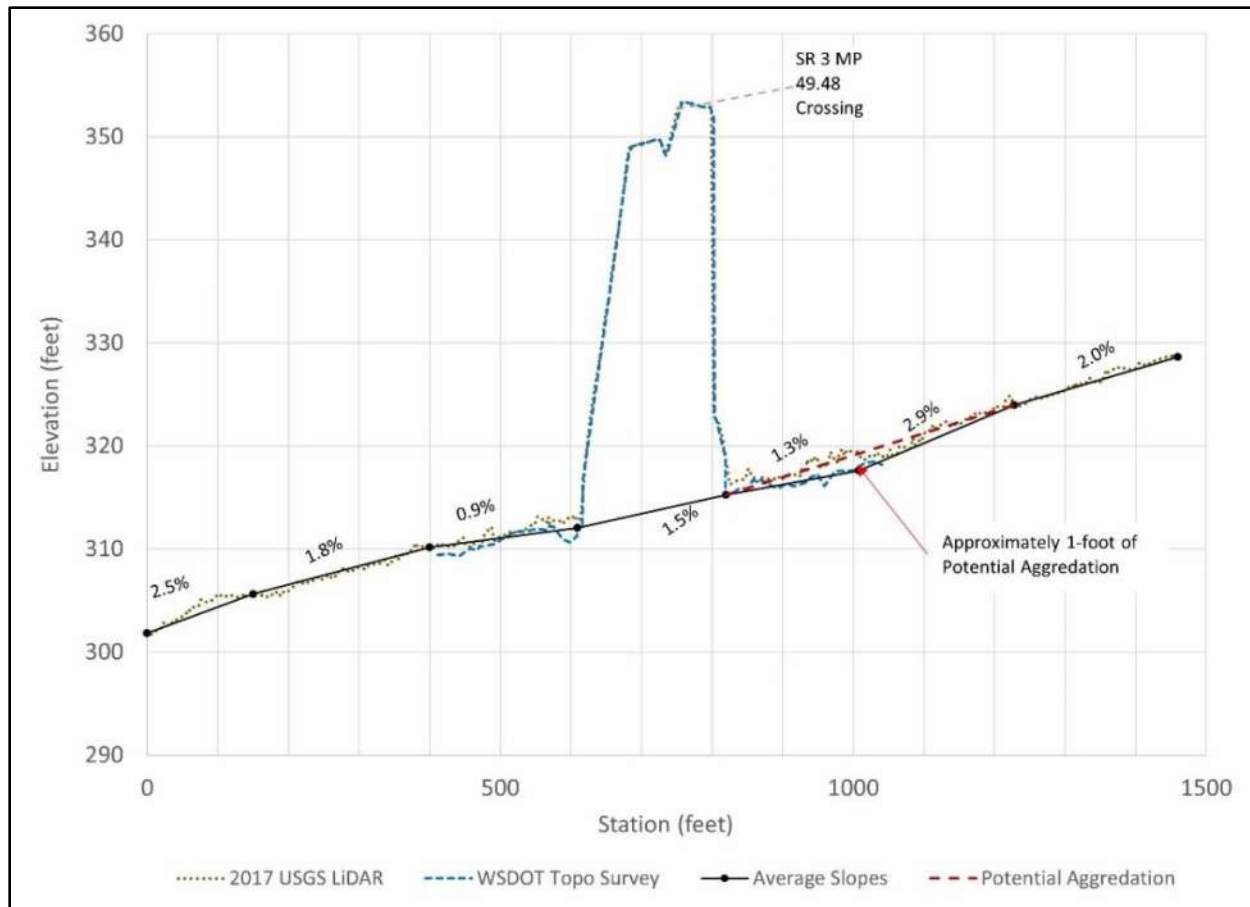
Figure 67: Potential long-term aggradation at the proposed structure upstream face

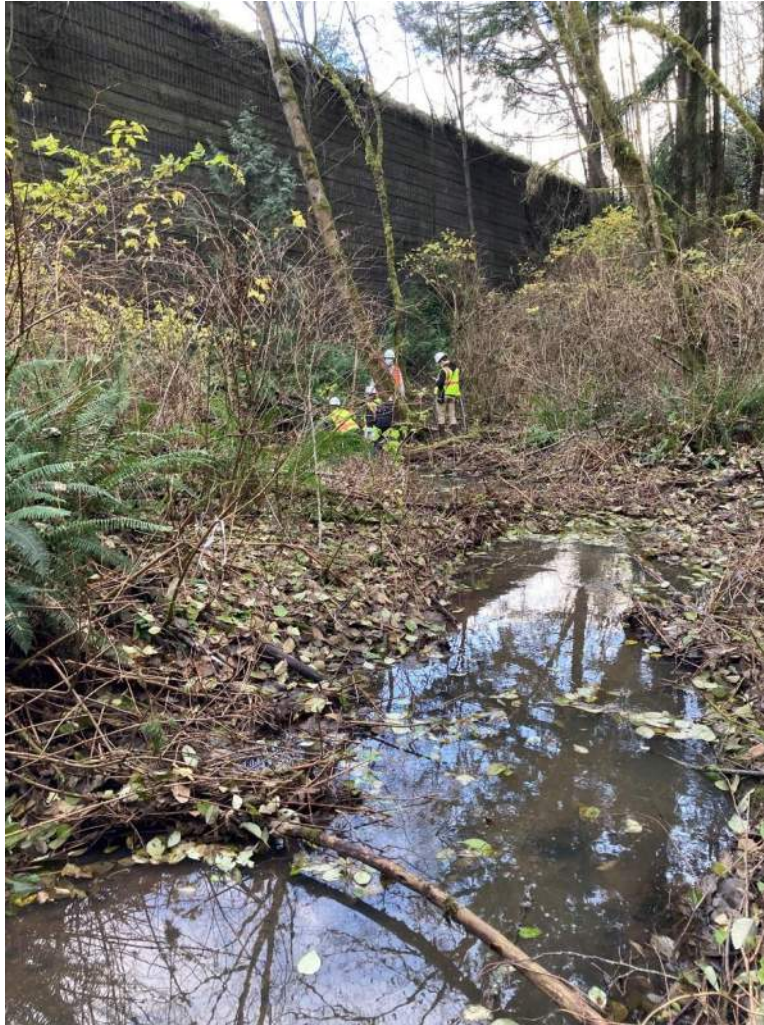
*Figure 10 Upstream of culvert looking towards culvert inlet and highway, vegetation is dominated by salmonberry and red alder.*

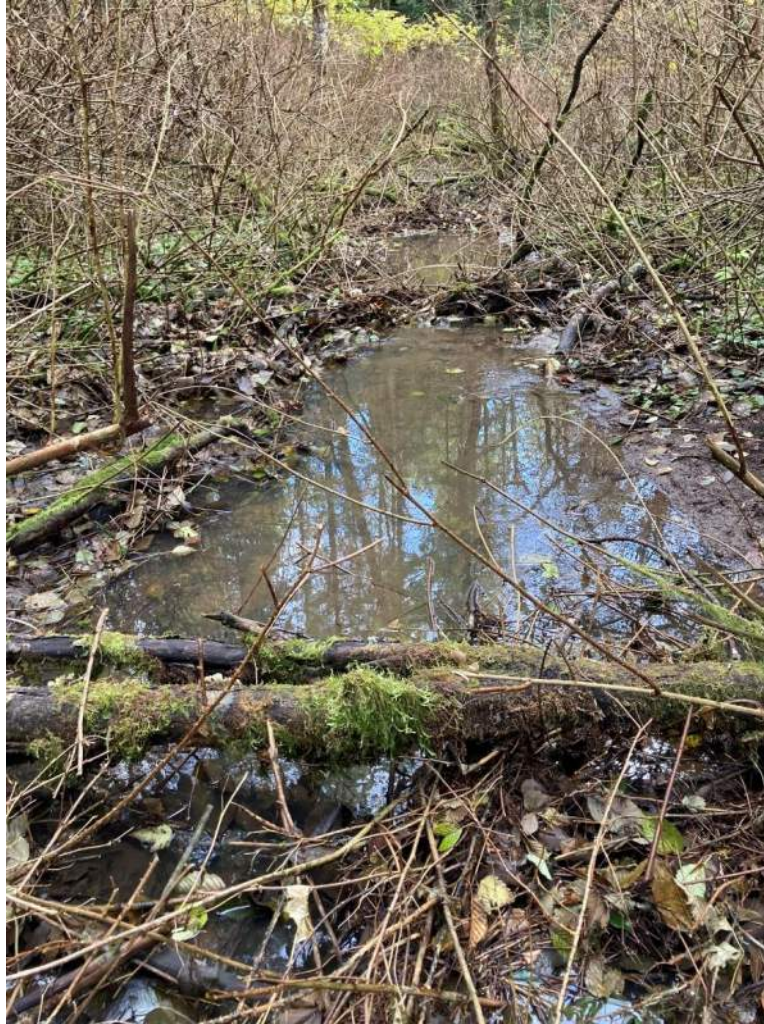
culvert for the 200 feet that was visited and extended further downstream. In this vegetation the channel is straight, shallow and has low banks. There is little channel capacity above the baseflow that was observed, and high flows readily access the overbanks resulting in a channel bed that is dominated by fines and organic matter. There are regular debris build-ups that span the channel creating drops on the order of 1 to 2 inches (Figure 13). This vegetation is likely the result of prior disturbance and this morphology is also present for about 100 feet upstream of the culvert and upstream of the reference reach.

*Figure 13 Typical channel morphology with alder and salmonberry vegetation*

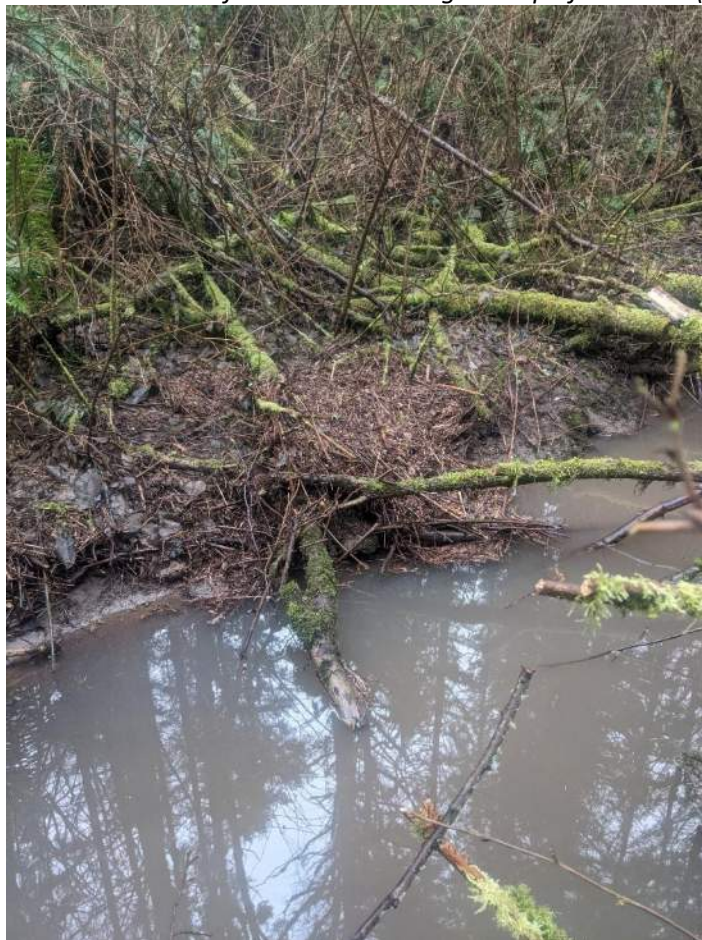
*A recent high flow event had accumulated lots of small debris along the top of the bank (Figure 20).*

Figure 20: Accumulation of small debris along the bank.

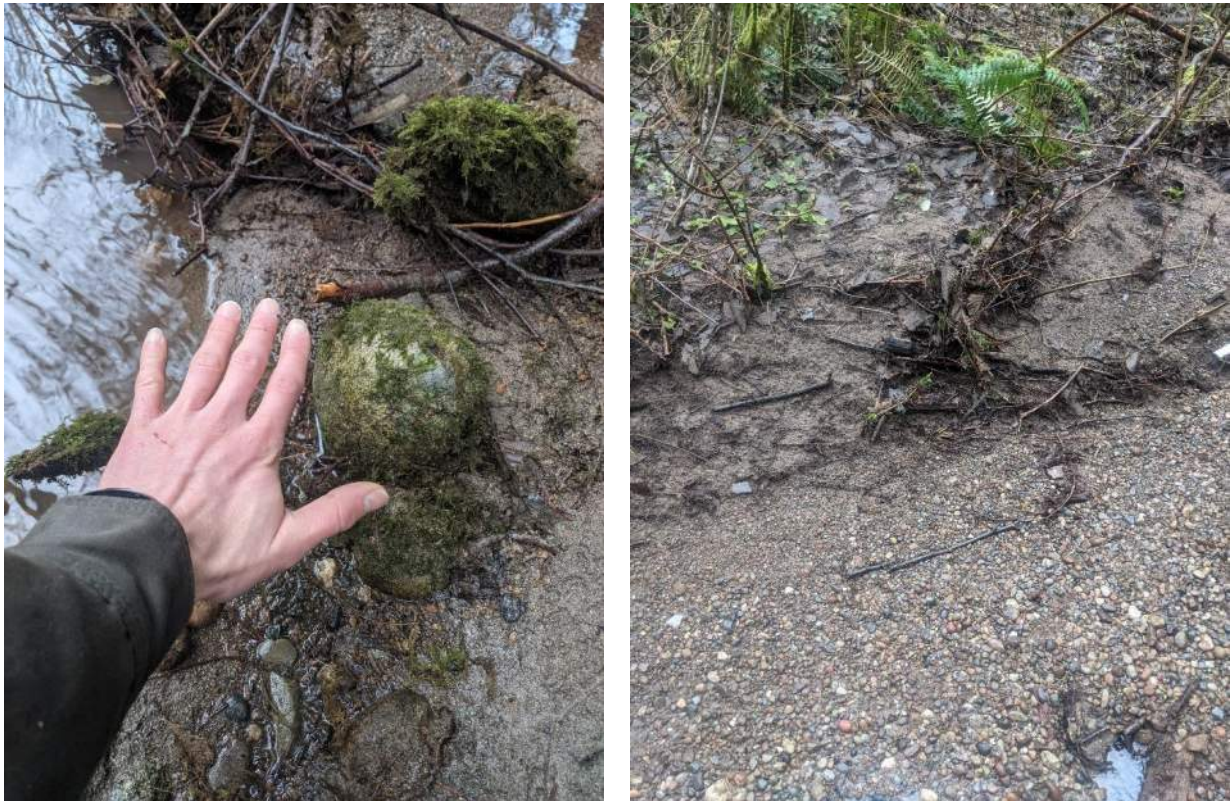
The channel material was coarser than during site visit #2 which took place on Dec 2, 2021. It was surmised that the high flow event might have caused this. There were some large gravels that were seen in this site visit, not seen in the previous one (Figure 21).

*Figure 21: Coarse and larger sediments were observed not previously seen in earlier site visits.*

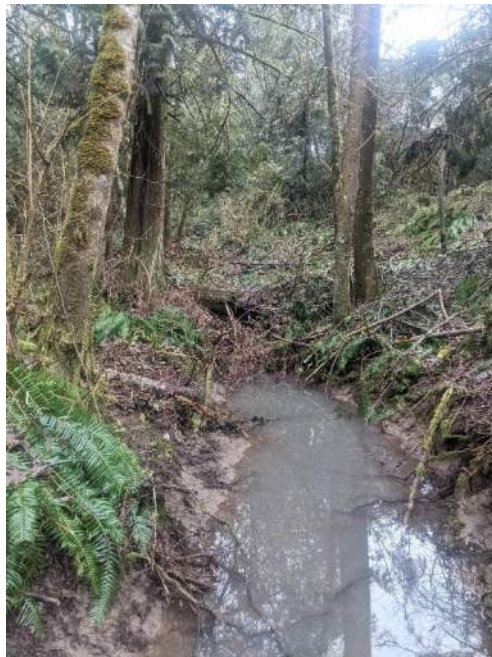
Based on rough field observations, the channel had dropped about 0.5 to 1-foot in some places. Speculation was made that the culvert might have been blocked upstream and a large flow was released as it became unblocked after a high flow event. These drops caused flows to drop lower than earlier site visits and the banks were much more evident.

*Figure 22: Drop in flow elevation and clearly evident banks.*
